Failure Analysis Of Impact-damaged Metallic Poles Repaired With Fiber Reinforced Polymer Composites

FAILURE ANALYSIS OF IMPACT-DAMAGED METALLIC POLES REPAIRED WITH FIBER REINFORCED POLYMER COMPOSITES

A thesis submitted in partial fulfillment of the requirements
for the degree of Master of Science
in the Department of Civil, Environmental, and Construction Engineering
in the College of Engineering and Computer Science
at the University of Central Florida
Orlando, Florida

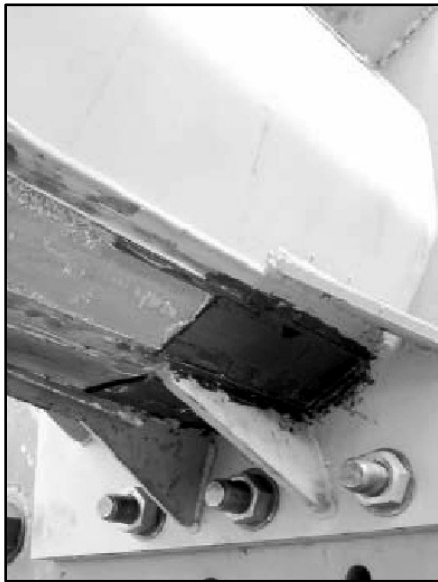
Figure 4. CFRP reinforcement on steel monopole
(Schnerch & Rizkalla , 2004)

Additional studies were conducted involving polygonal monopoles strengthened with CFRP. These studies involved pultruded CFRP plates or wet-layup CFRP sheets that were adhered at the base directly on the outside of large steel monopoles. Due to the cross-sectional geometry of these poles, the FRP was applied in flat sheets as can be seen in Figure 4. These studies demonstrated that FRP is a viable option for increasing the strength and stiffness of poles subjected to a cantilever loading, as can be seen in Figure 5 (Schnerch & Rizkalla , 2004).

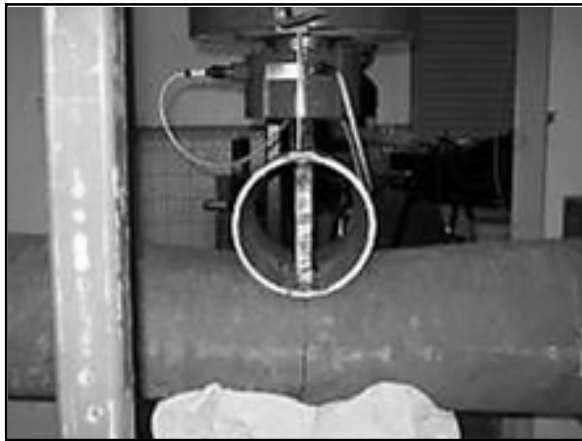
Figure 36. Application of dent to S2

The sections were each dented near the base of the poles to represent damage from vehicle collision. The dents were induced by a hydraulic actuator fitted with a reinforced steel cylinder centered at 22in (229mm) from the base plate (see Figure 36 and Figure 37). This distance was chosen because it represents the average height of a typical SUV bumper. Both the Sikadur[®] and Tyfo[®] repair systems were then used in the axial and transverse directions to repair the dented region. The orientation and fiber type of each composite layer are listed in Table 4.

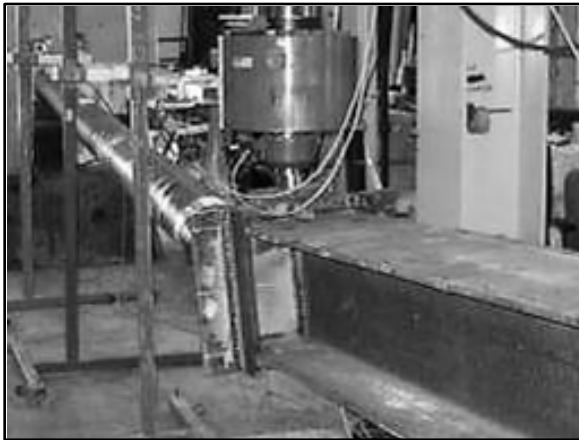
Figure 38. Deformed shape of S2

The deeper denting procedure produced a lateral distortion of the cross section at the centerline of the dent location, resulting in large plastic deformations in the steel at that location. Consequently, the extent of the dent axially along the pole, coupled with the kinematic rotation of the pole cross section at the centerline of the wrapped region, led to a different failure mechanism than observed during the testing of pole S1. The force-displacement response for the five displacement gauges and the actuator displacement are given in Figure 41 and the deformed shape is shown in Figure 38. The displacement presented is as measured.

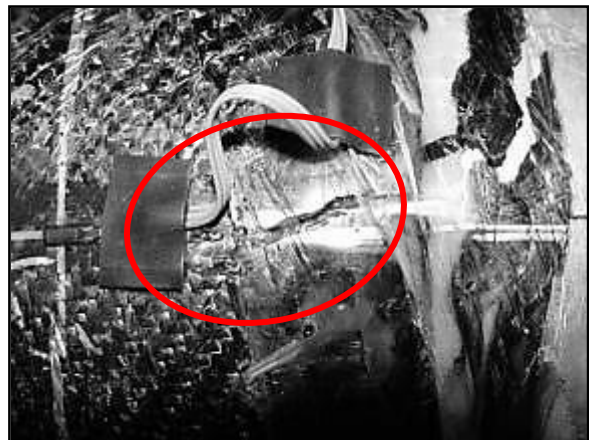
Figure 75. Ruptured FRP on pole A2

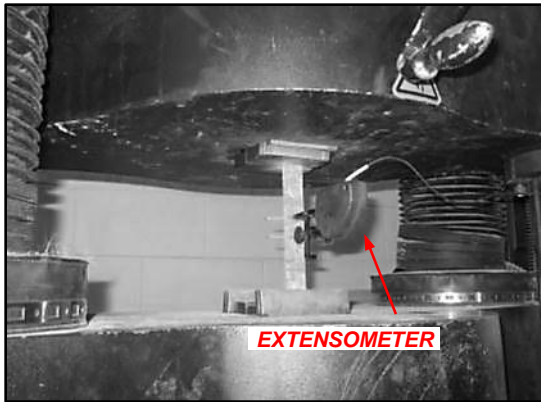
Figure 87. Tensile coupon being tested in UTM

The fibers were orientated axially for the unidirectional weaves and in the 0°/90° directions for the bi-axial weaves, with respect to the coupon geometry. These coupons were then tested in an Instron/SATEC 200 kip universal testing machine (UTM) following ASTM D3039 testing standards (Figure 87). Typical coupon failures are shown in Figure 88 through Figure 90.

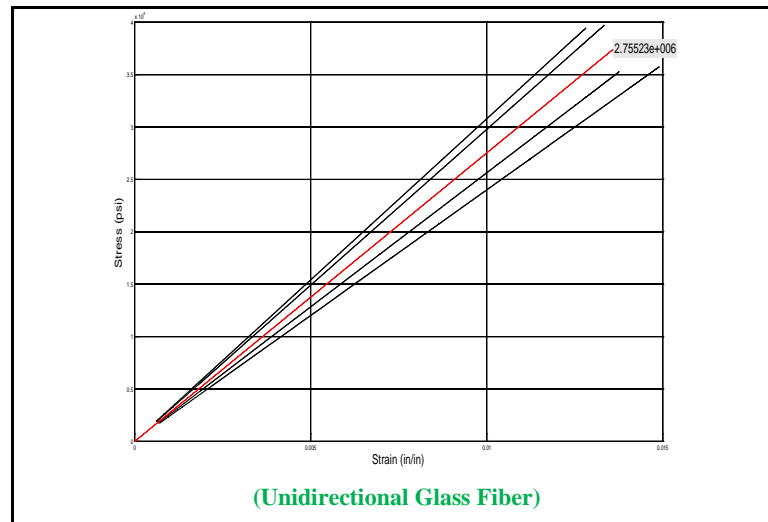
Figure 91. Tyfo® GFRP composite tensile coupon data
